IDLER Pulley Issues---Cummins 6BT / 6BTA 5.9

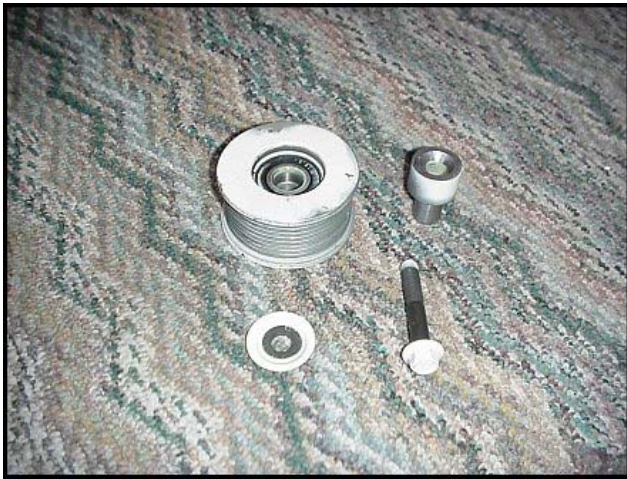
Original Parts from about the 1988 engines

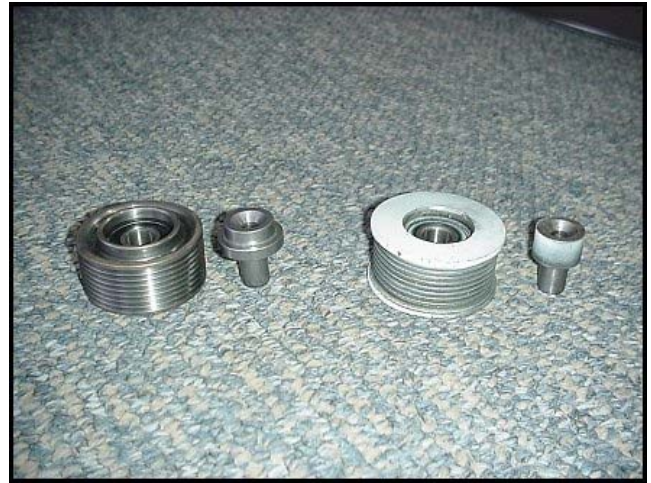
Old vs New designed Cummins parts—To this Very day about 10 years later, I still cannot Figure out what Cummins was thinking.....
